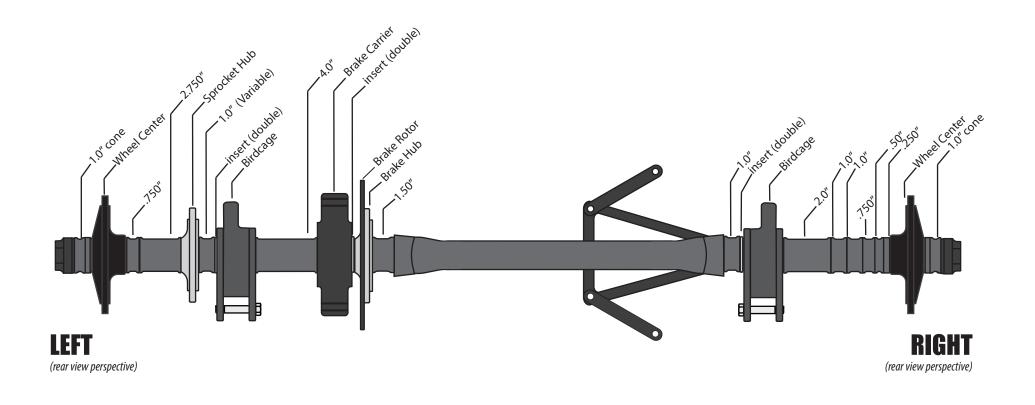
Notes Years 2014 and prior may require 7.75" spacer inside of right rear birdcage

Sprocket hub position will vary based on make & model of engine. Proper chain alignment is important
